Technical Bulletin

The Anatomy of a Squeak in Subfloor Application

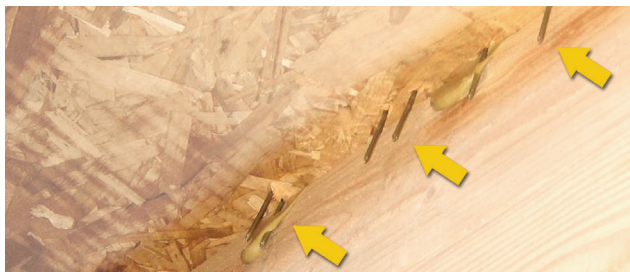
2. Missed Nails & Screws - Unavoidable in Homebuilding

The sheathing to joist connection is not consistently secured with fasteners.

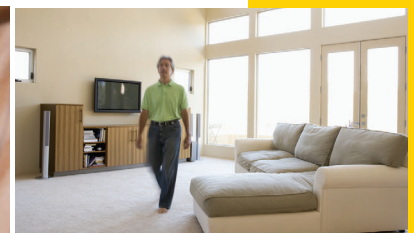
4. Squeak is Formed - Metal moves against wood, causing a squeak.

Normal household activity, including foot traffic and furniture placement, causes shiner nails to move against sheathing and the joist. A squeak is created with as little as 0.2mm movement.

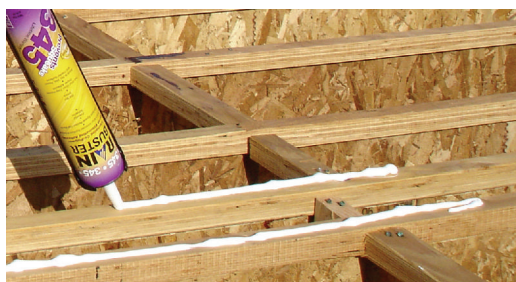
RAIN BUSTER SQUEAK-FREE CONSTRUCTION

RainBuster 345 Squeak Eliminator is entirely unlike typical subfloor adhesives. Designed specifically to prevent floor squeaks, its innovative technology permanently maintains the sheathing to joist bond. Experience a dramatic reduction in floor squeaks, call back costs and warranty claims by specifying RainBuster 345.
